# New Online Salt Analyzer Captures Process Upset Allowing Quick Mitigation of Threats

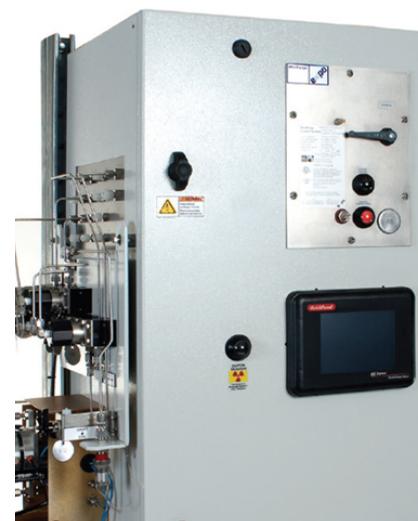
FIGURE 1: ONLINE SALT ANALYZER (OSA)

A Gulf Coast refiner installed the Nalco Water 3D CrudeFlex Online Salt Analyzer (OSA) at the desalted crude outlet of one of the crude units, complimenting the 3D TRASAR™ Technology for Crude Overhead Systems (COS) which was already installed. With the addition of the online analyzer, both inorganic and organic chlorine were detected, providing real time chlorine measurements. This ensured upsets could be detected quickly with mitigating actions taken, ensuring ongoing desalter performance met critical KPI's.

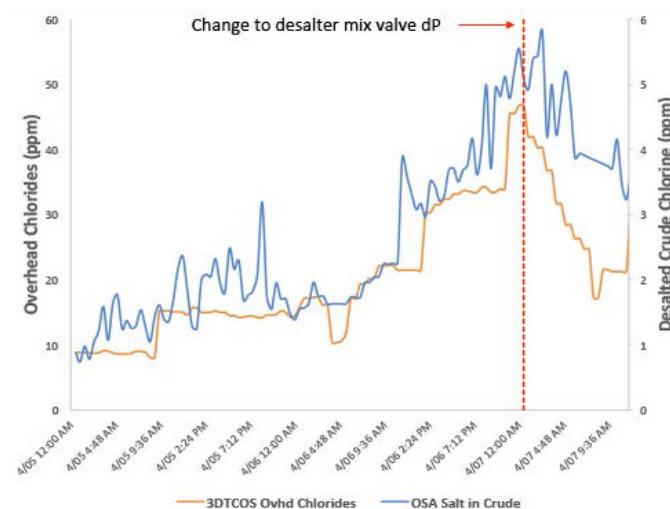
FIGURE 2: CHLORIDE DATA FROM OSA + 3D TRASAR COS

Shortly after commissioning the OSA, the refiner experienced an operational issue and consequently, had to reduce feed rates. After which, the OSA showed a sharp increase in salt exiting the desalter, with the 3D TRASAR system revealing an increase in overhead chlorides that quickly exceeded the control value of 25ppm (see Figure 1).

The online analyzers, linked to the refinery control system, alerted operations of these increases and quickly determined that the reduction in feed rate resulted in a lower mix valve dP. Reduced mixing efficiency and poor contact between wash water and crude oil, resulted in desalting efficiency being compromised.

Once recognized, the mix valve dP was increased back to typical operating levels and the salt-in-crude and overhead chlorides began to reduce almost immediately, returning to typical levels.
