Nalco Water's ACRYL-EX Program Delivers Multiple Benefits with a Single Application for MMA Producer

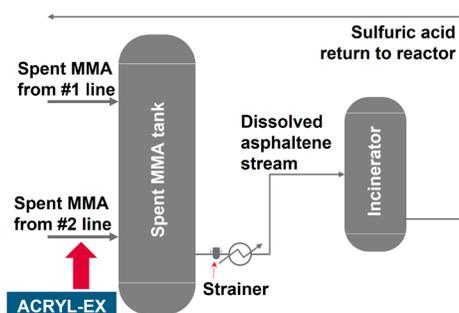
FIGURE 1: INJECTION LOCATION & PROCESS FLOW

The waste from MMA unit two is mixed with the ACRYL-EX antifoulant and is then directly introduced to the spent acid tank bottom. MMA waste from MMA unit one is introduced into the waste tank from the top and then mixed with the dispersant.

After detailed technical exchanges with the producer, the ACRYL-EX dispersant was injected into the waste tank. During the first intermittent treatment, the producer witnessed a significant improvement in filter plugging and cleaning frequency. Later, the customer agreed to use a newly developed dispersant as an alternative product. This new dispersant dosage is 30-40 ppm based on the waste return flow. Two months later, this dispersant began being fed into the waste tank.

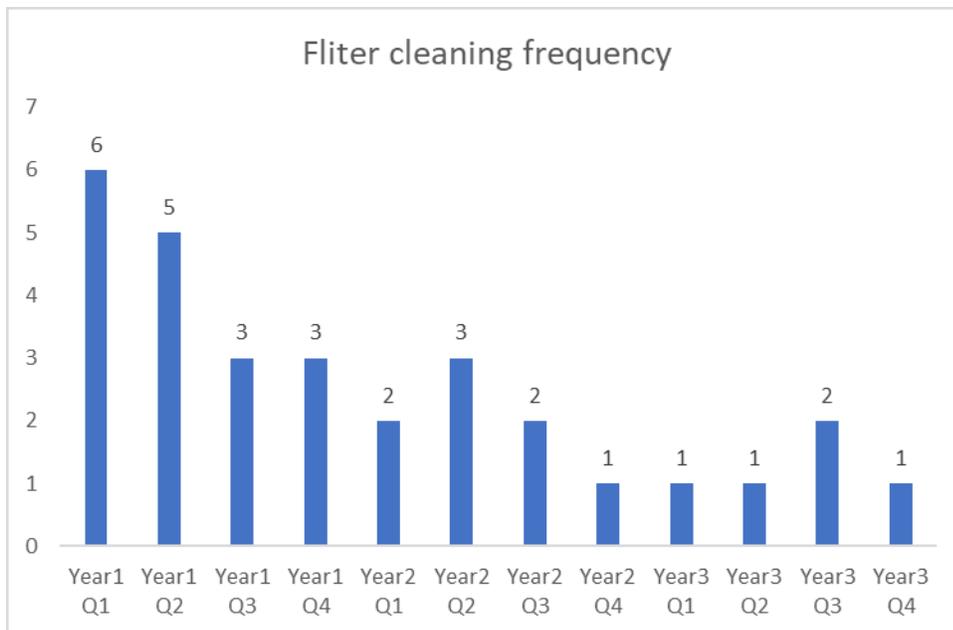
FIGURE 2: NUMBER OF FILTER CLEANINGS DUE TO PLUGGING

The frequency of filter plugging was gradually reduced from 6 per quarter to only 1 per quarter, as shown in Figure 2. The asphaltene liquid level of the MMA waste tank - another fouling indicator - has steadily decreased. With fewer blockages, the inflow and outflow of waste kept a balanced rate, and even the asphaltene level decreased accordingly. The producer decided to inject the new dispersant continuously due to the outstanding performance seen from this ACRYL-EX antifoulant.

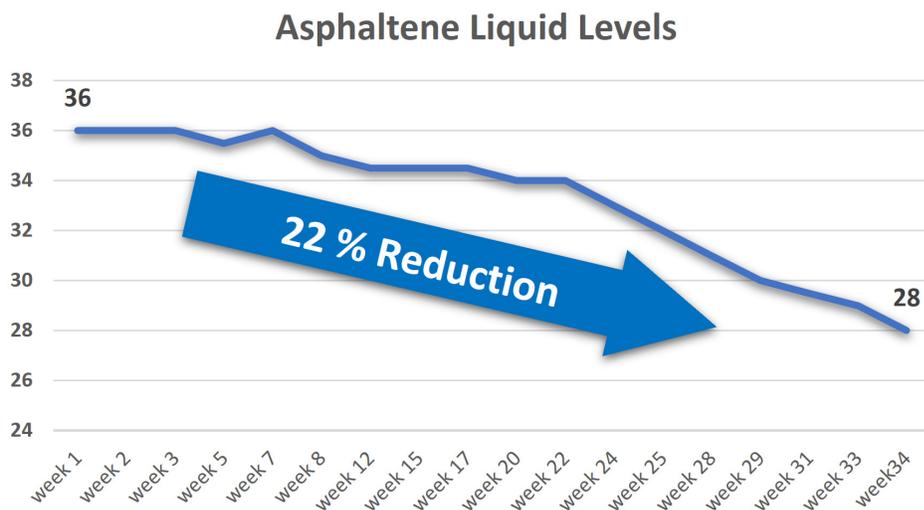
FIGURE 3: ASPHALTENE LIQUID LEVELS - LOWER LEVELS INDICATED LESS FOULING
